Remedial Investigation Report

General Motors LLC
Former General Motors
Assembly Plant Site
Sleepy Hollow, New York

January 2012

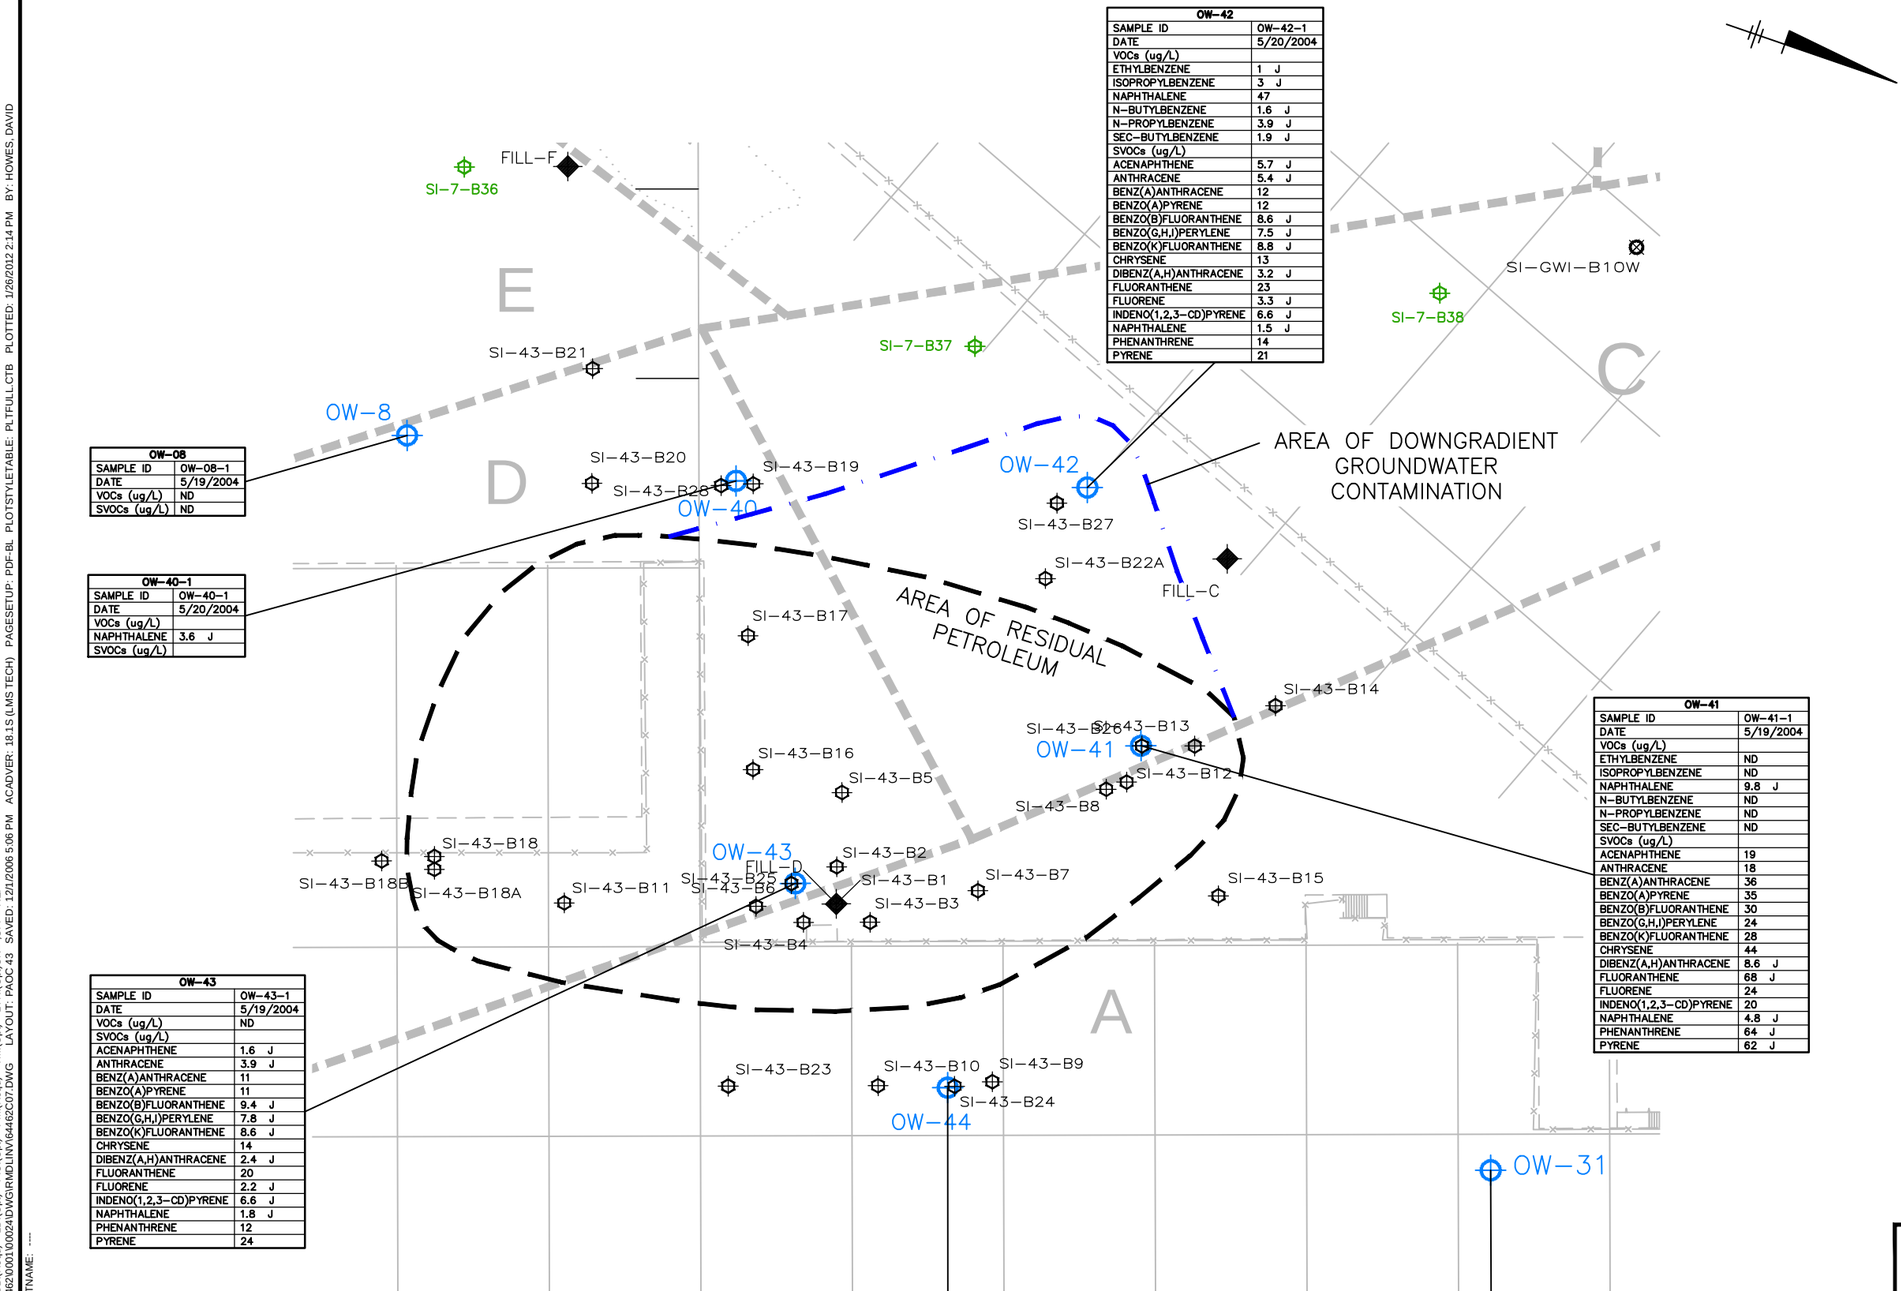
FIGURE 10C

wells installed in April 2004, including a monitoring well near the B-6 and B-19 locations, are discussed in Section 6.2.4. Figure 10C identifies the areas of residual petroleum and associated downgradient groundwater contamination.

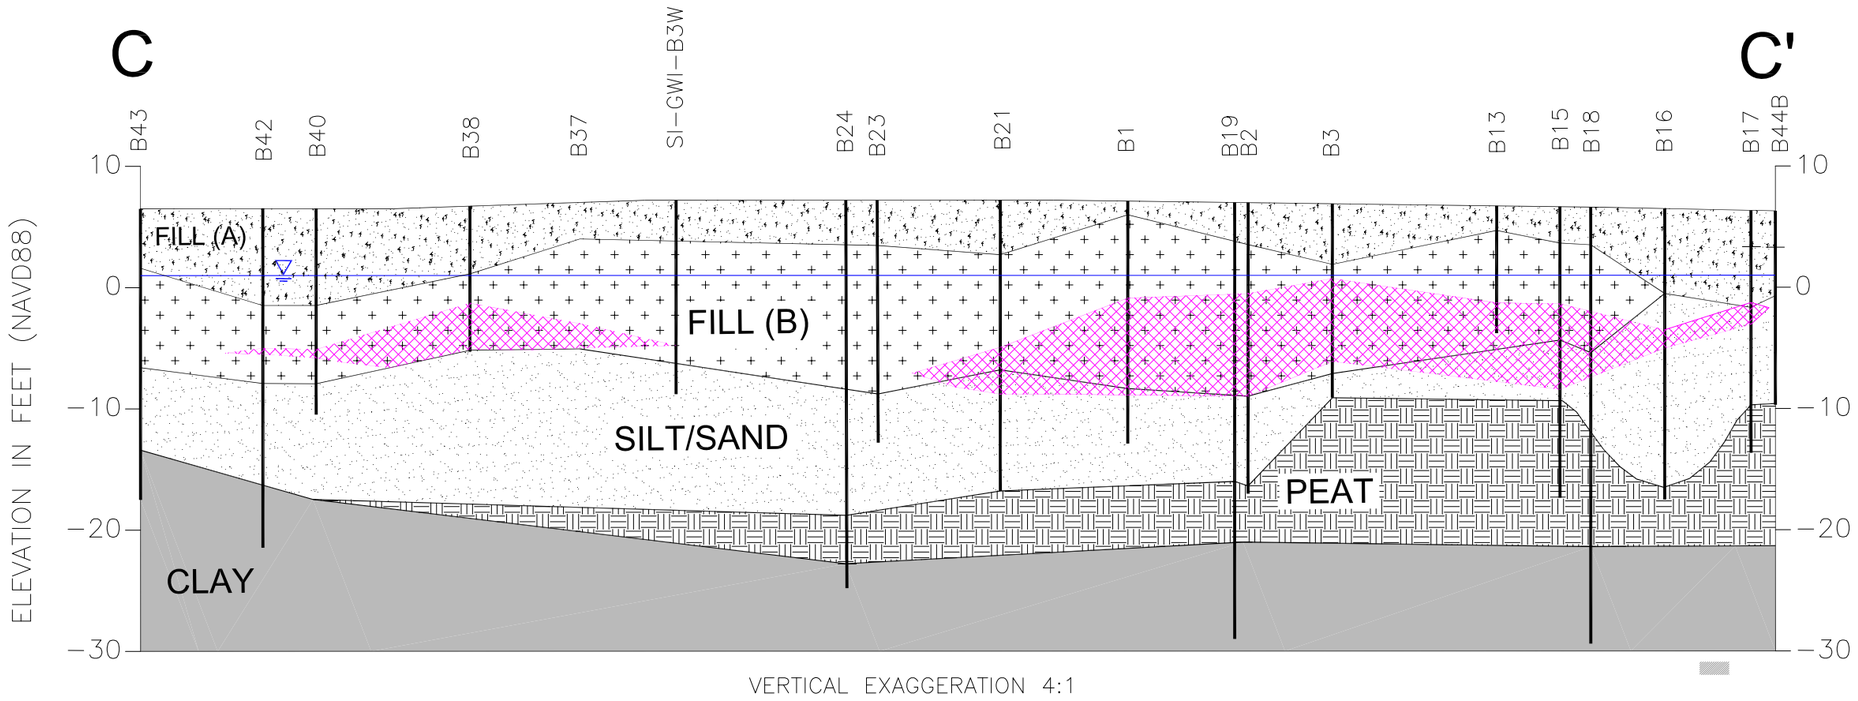
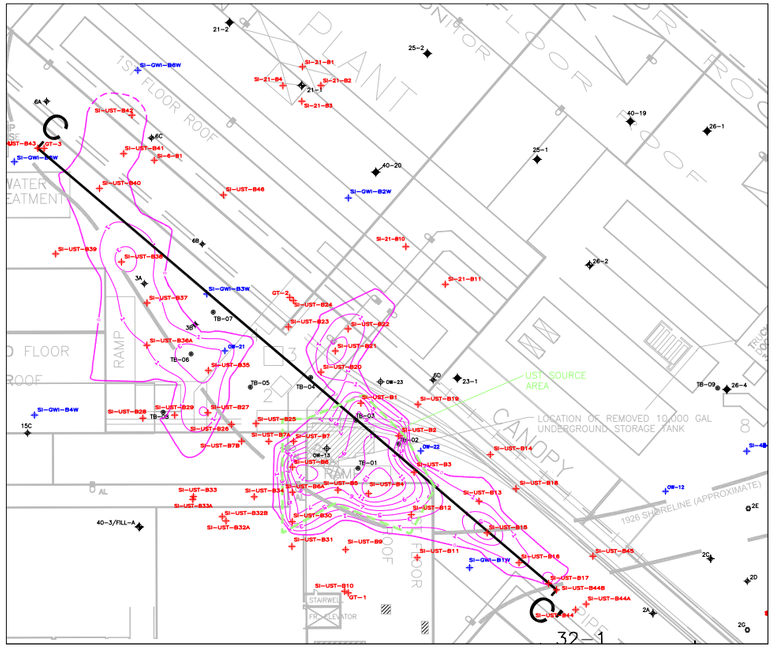
Evidence of oil contamination observed (e.g., staining, odor, sheen,PID readings >100 ppm).

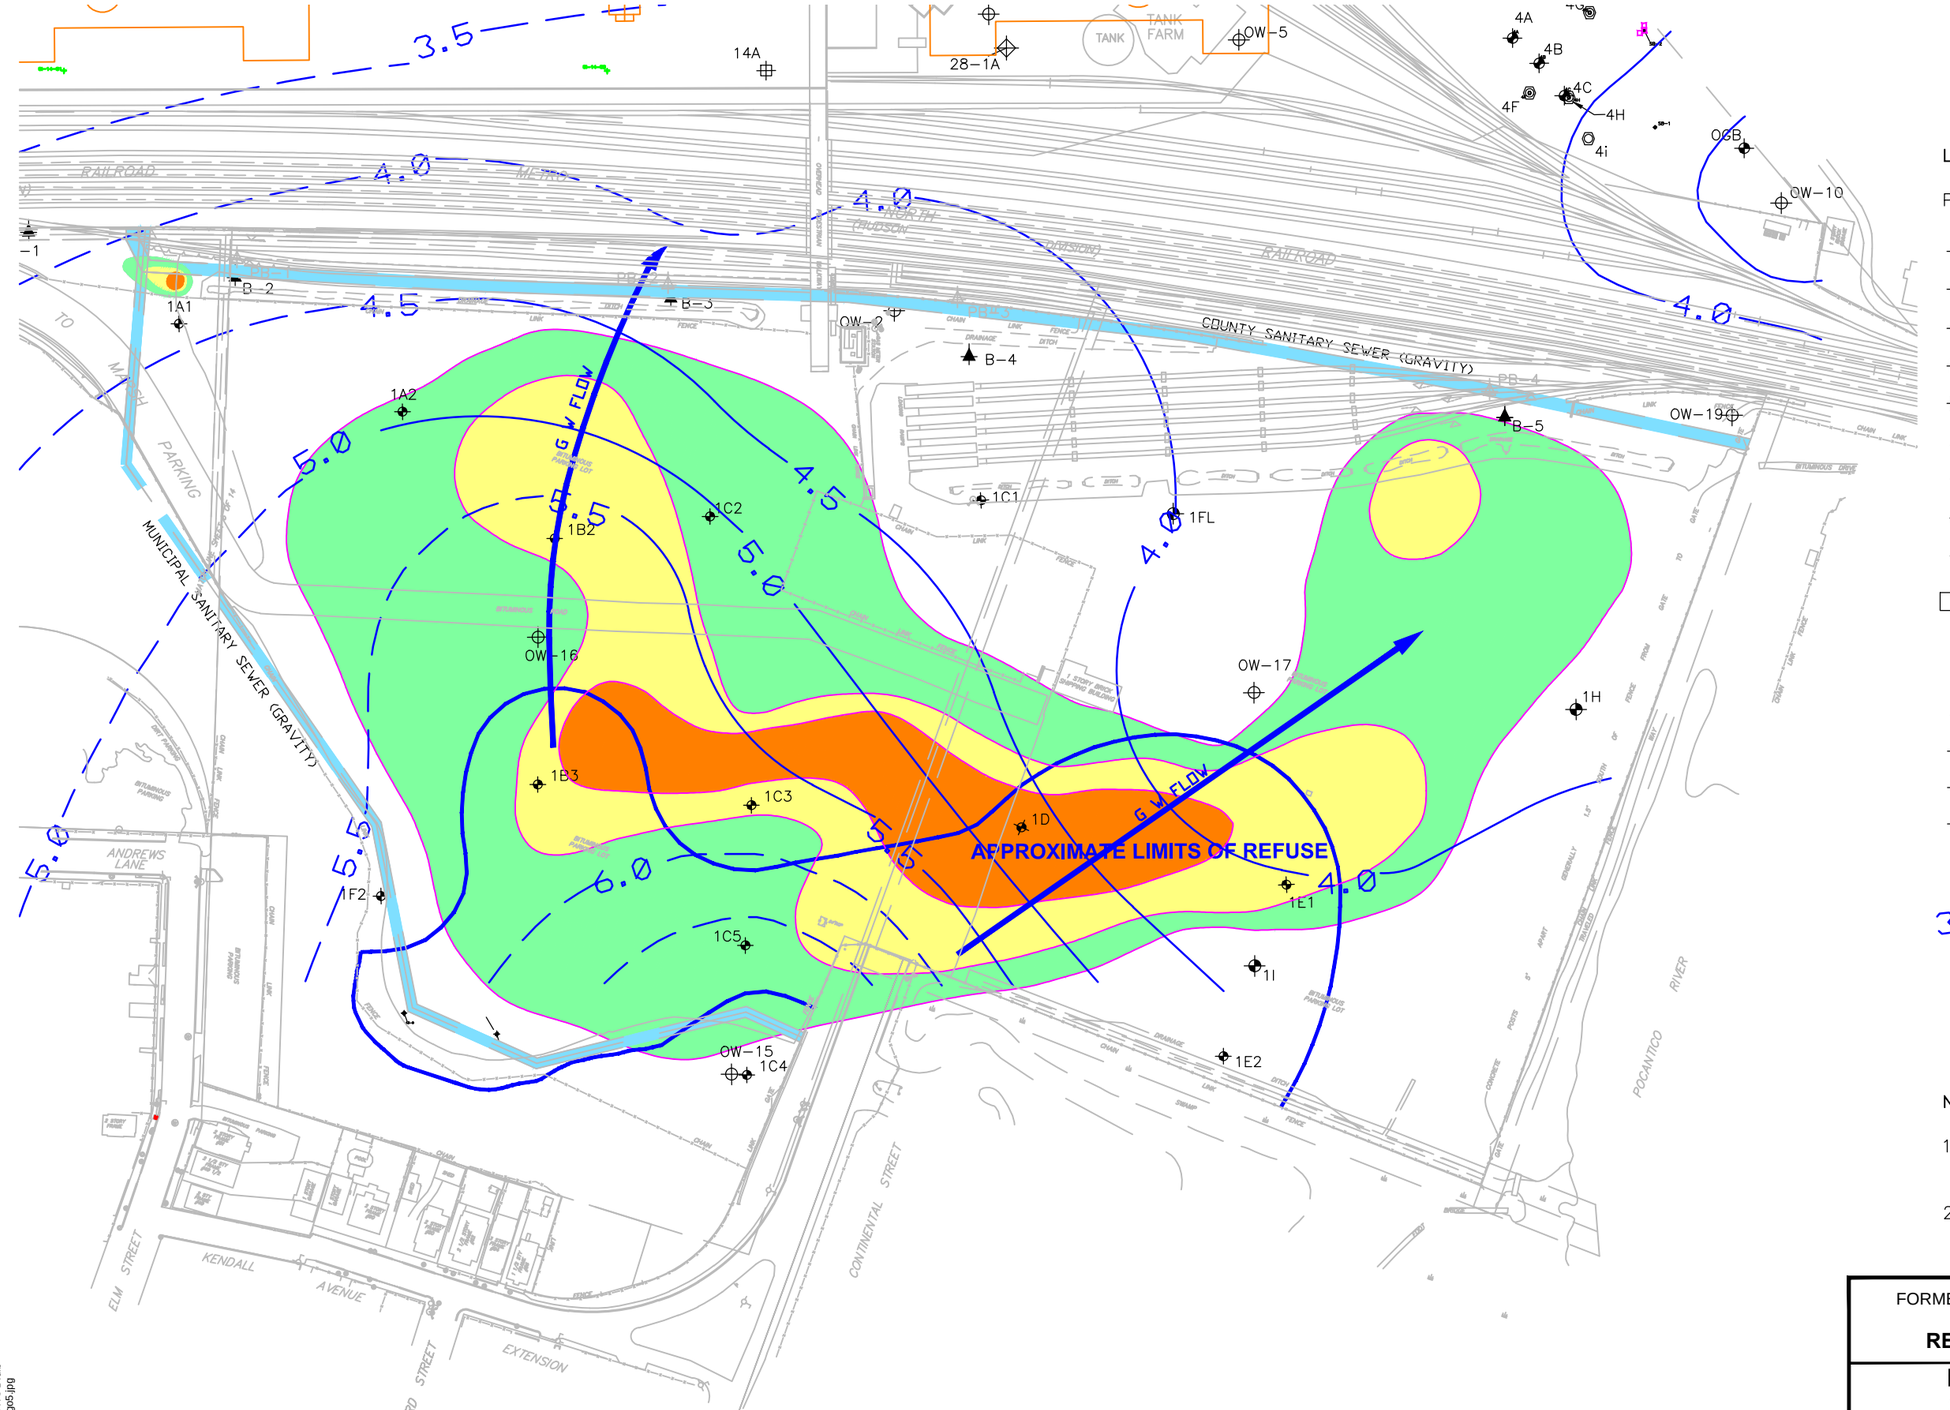
FIGURE 15A

Table 11 presents the results of field measurements taken with the landfill gas monitors on the East Parcel. The soil gas sampling and (or) measurement points are shown in Figure 15A, along with contours (concentration isopleths) of the methane results. The shape of the area exhibiting the highest methane results (70% to 100% methane) corresponds with the shape of the former landfill.

As illustrated in Figure 15A, approximately half of the area of the highest methane concentrations is located above the landfill area, with the remainder shifted slightly to the west. An overlay of the methane contours with the groundwater-flow contours (Figure 15B) suggests that the methane plume originated within the former refuse area and is migrating along the groundwater flow path, until the gas is naturally released to the atmosphere.

There is an additional small area off the asphalt at the southwest corner of the East Lot (SG-42 location) exhibiting elevated methane. This area is near the junction of the local municipal sewer lines. It is possible that the municipal Village Department of Public Works (Village) sanitary sewer line corridor is a preferential pathway for methane originating at the landfill (this leg of the local sewer line passes through the landfill), although methane was not detected above this line much closer to the landfill. It was learned, through personal communications with the Village, that a failed section of the Village sewer line in the East Parcel was abandoned to make the current connection to the county system and it may terminate at or very near to the SG-42 location exhibiting methane gas. The approximate location of that abandoned section (from a GMC site plan) is shown in the background on Figure 15A. Iterative sampling in response to an initial high gas reading off the edge of the asphalt confirmed that this isolated area of methane was confined to the immediate vicinity of the junction

between the Village and Westchester County sewer systems (Figure 15 A), and does not extend beyond the East Parcel.
